# Initial Report

1234 Andes Ln, San Marcos, Tx

Example Job - James Vasquez

Water

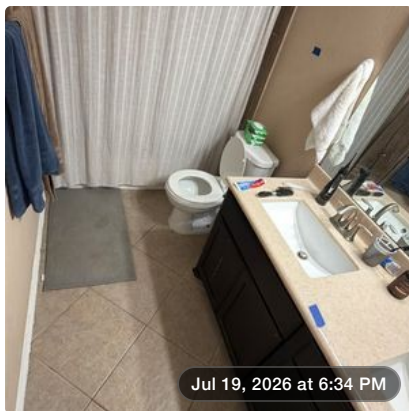
## Cause of loss

Bathtub overflow on July 4th.

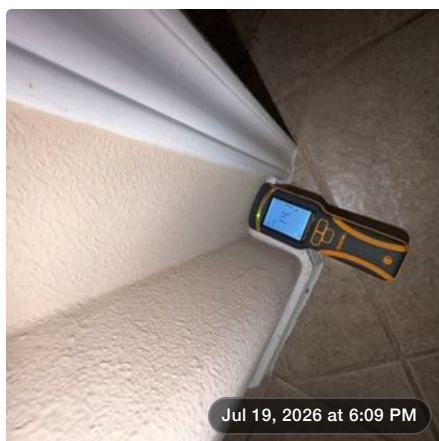
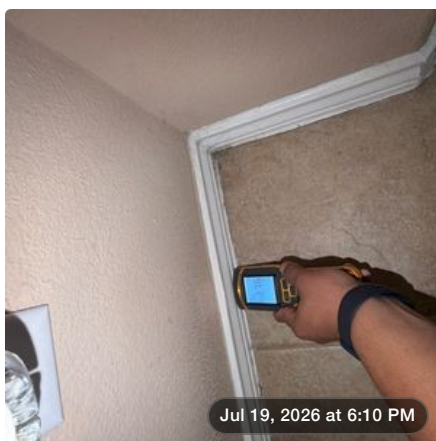
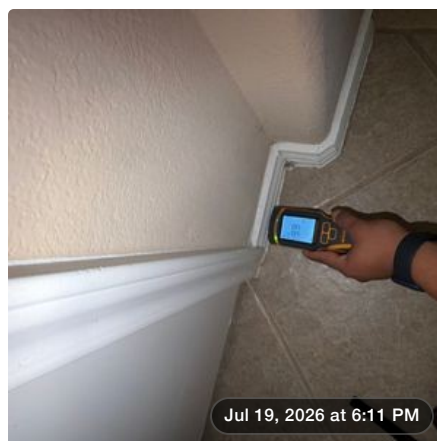
There are baseboards, and drywall still containing high levels of moisture.

Following IICRC guidelines, materials that hold moisture for more than 72 hours, have a higher risk of microbial organism amplification.

Therefore, we recommend removal of any materials containing moisture.

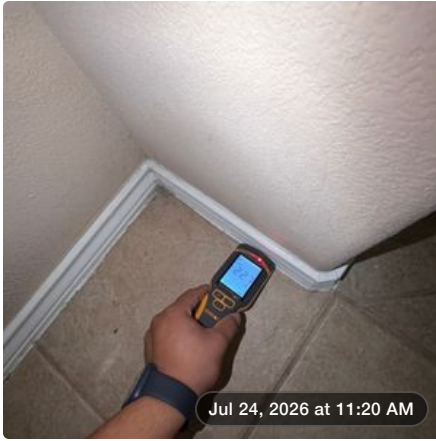
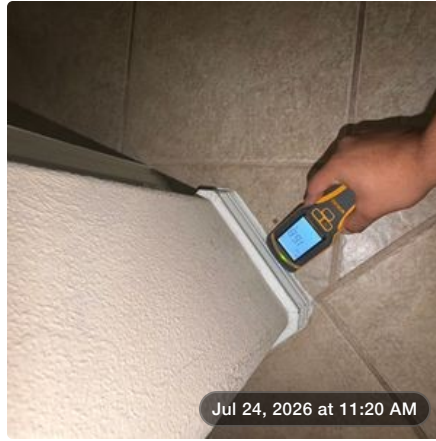
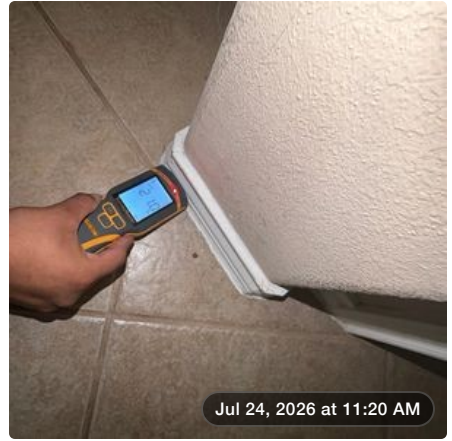
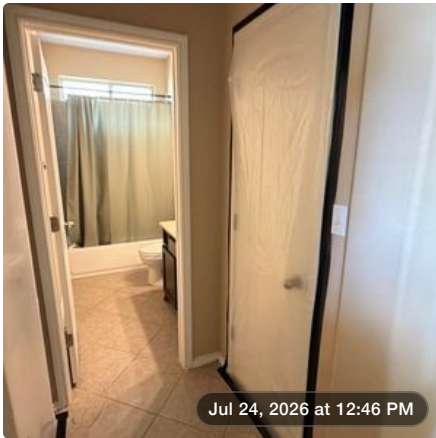
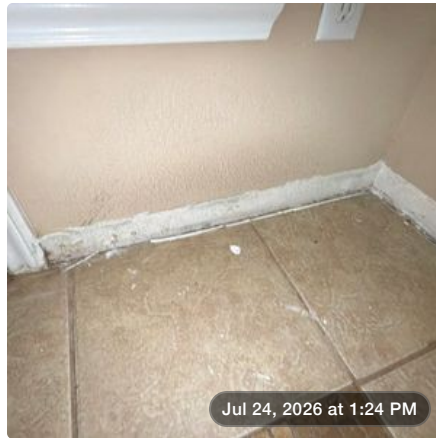
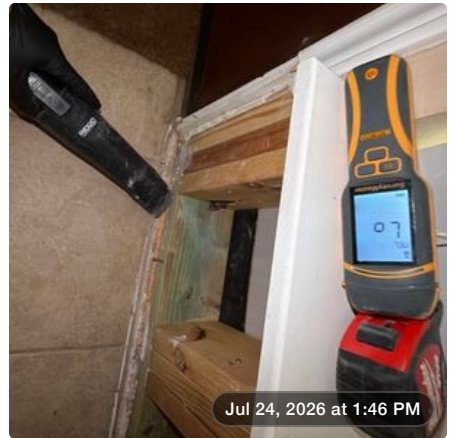
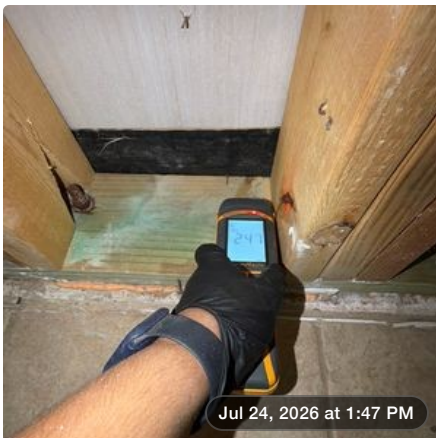
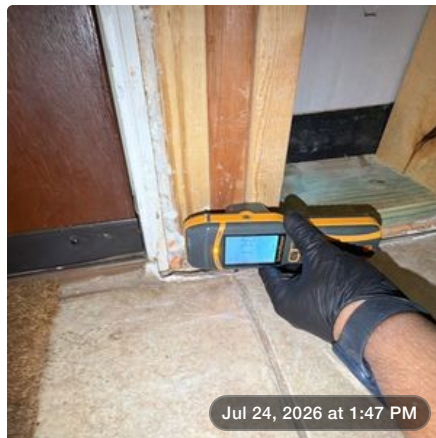
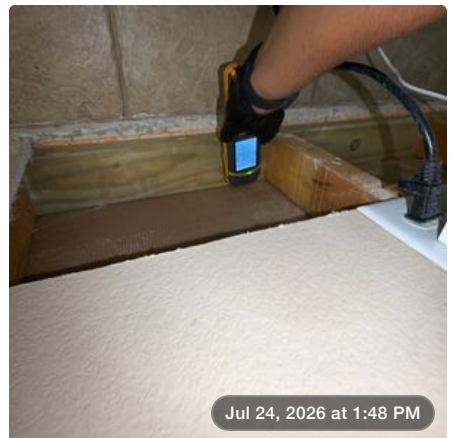
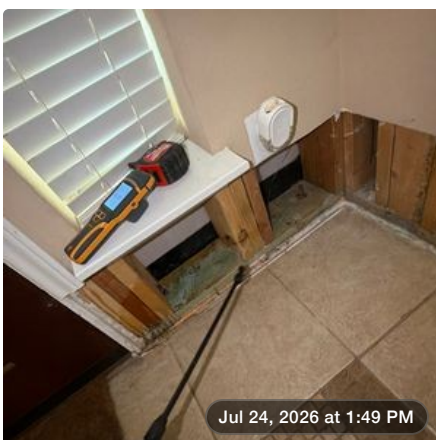
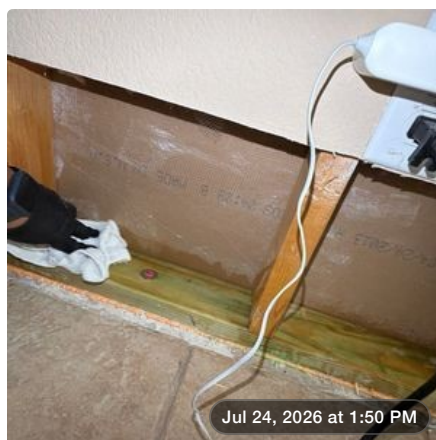
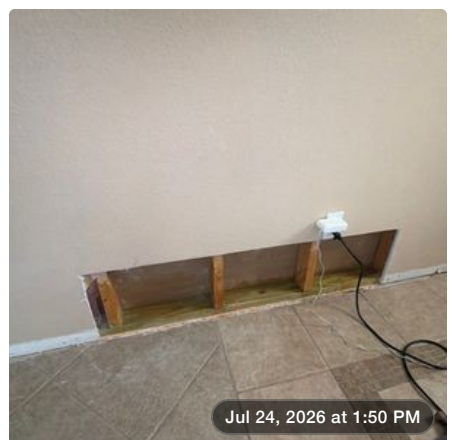
## Work Performed

All areas were re-evaluated, to confirm moisture.

Only areas that had moisture:

Baseboard removal, 1 ft flood cuts, and insulation removal.

Anti-microbial was sprayed and all areas HEPA vacuumed.

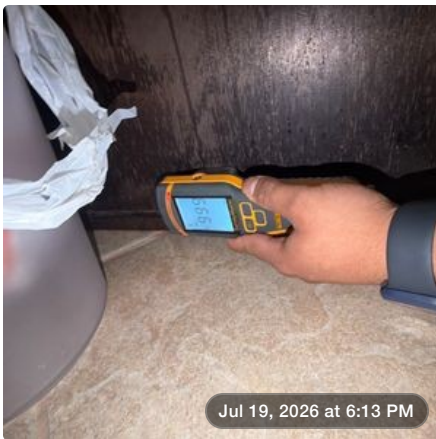
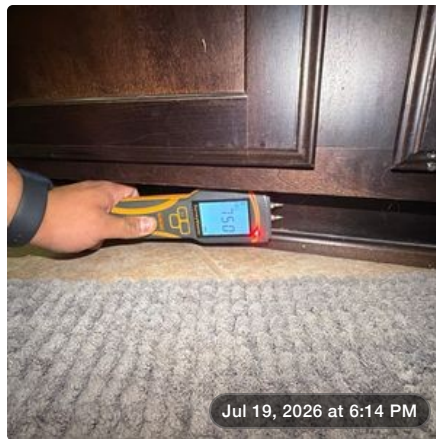
Bathroom vanity still holds 99.9% moisture readings.

Following IICRC guidelines, materials that hold moisture for more than 72 hours, have a higher risk of microbial organism amplification.

Therefore, we recommend removal of any materials containing moisture.

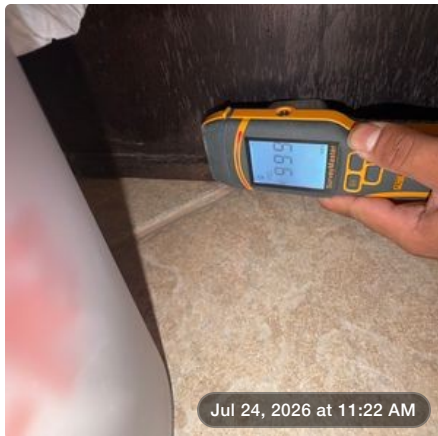
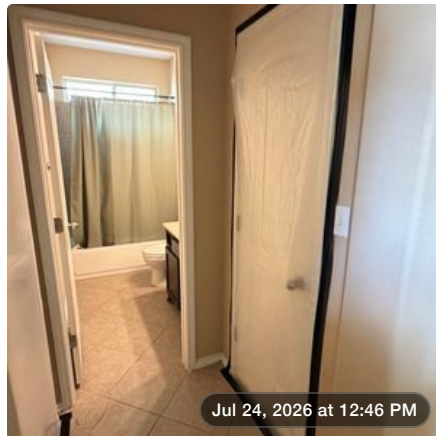
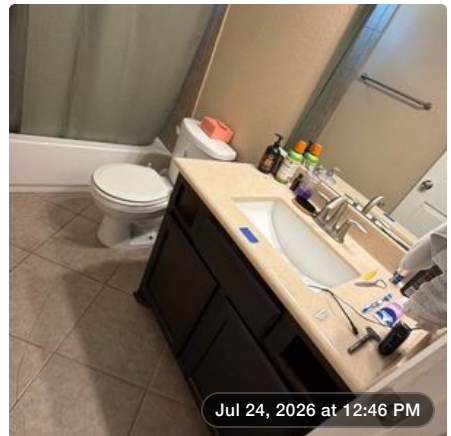
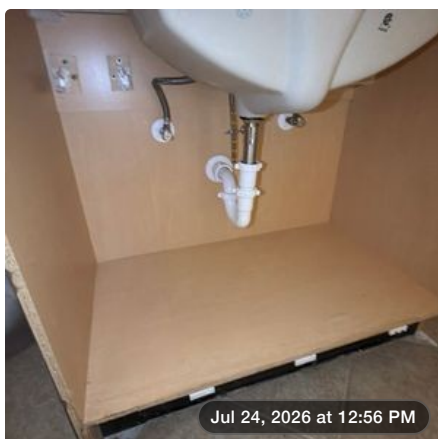
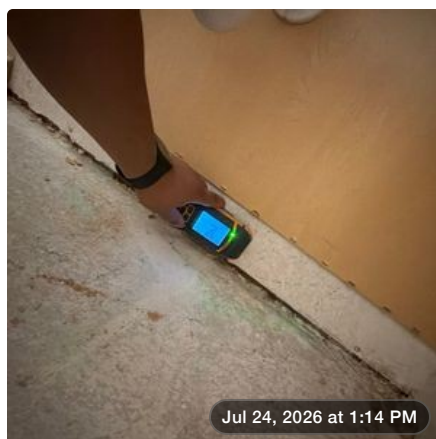
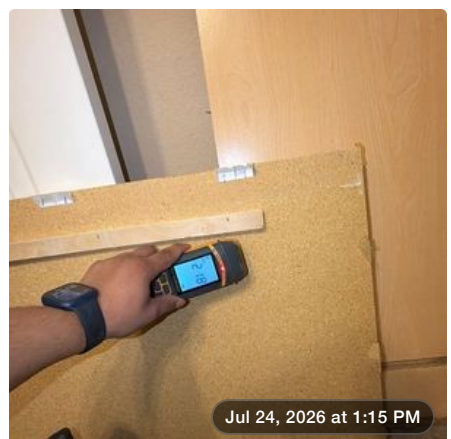
## Work Performed

After removing cabinetry, drywall behind was inspected, no discoloration, or moisture was present. therefore, no need to remove anything but the affected cabinetry.

All affected cabinetry that remained with 99.9% moisture, for more than 72 hours has been removed, per IICRC S500 guidelines.

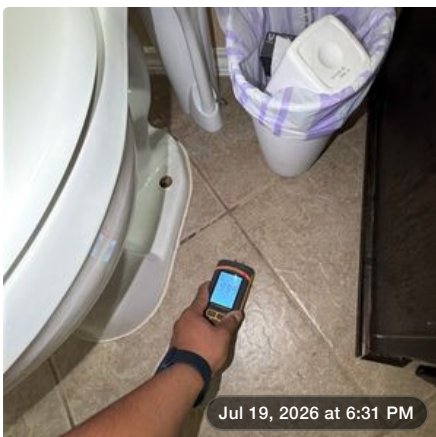
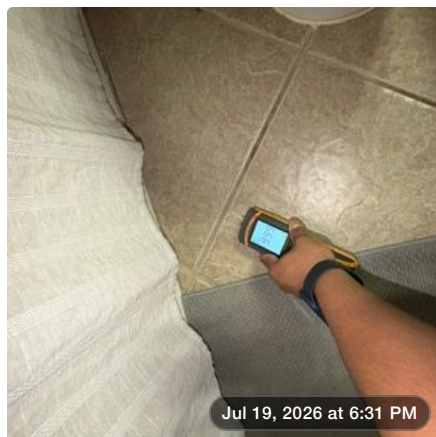
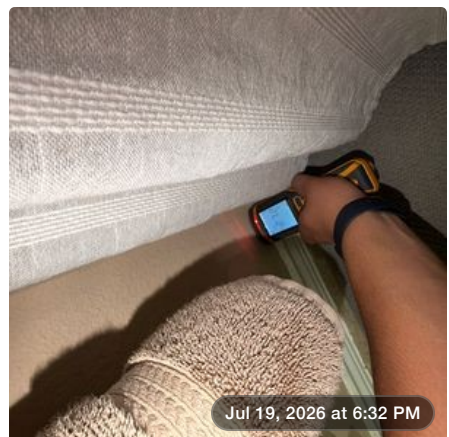
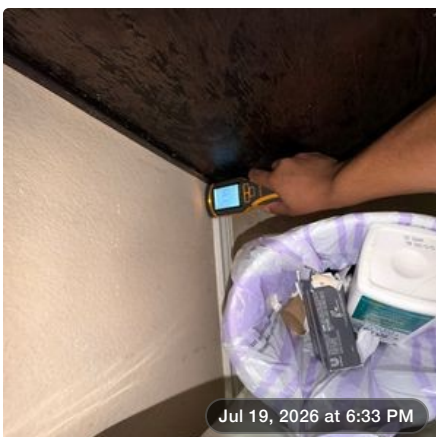
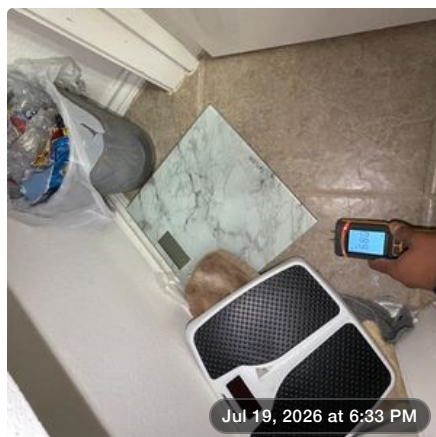
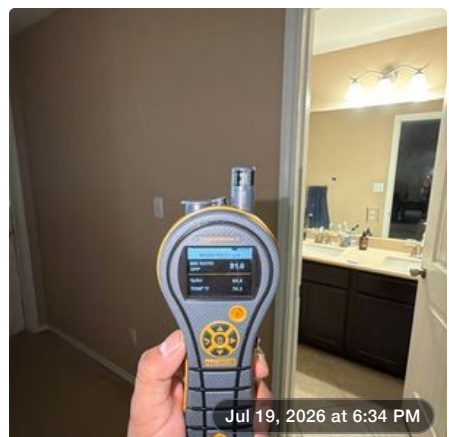
There are baseboards, drywall, tile flooring, subfloor beneath tile, and bathroom vanity still containing high levels of moisture.

Following IICRC guidelines, materials that hold moisture for more than 72 hours, have a higher risk of microbial organism amplification.

Therefore, we recommend removal of any materials containing moisture.
