# Drying Log

1234 Andes Ln, San Marcos, Tx

Example Job - James Vasquez

Water

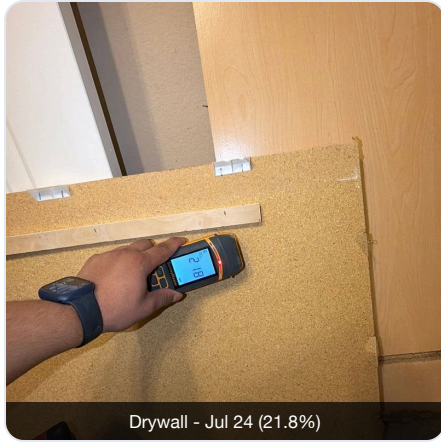
| | JUL 24 | JUL 25 | JUL 26 | JUL 27 |
|---|---|---|---|---|
| Drywall<br>DRY STD 1% | 21.8% | 12.6% | 6.4% | 0.8% |

Drywall - Jul 24 (21.8%)

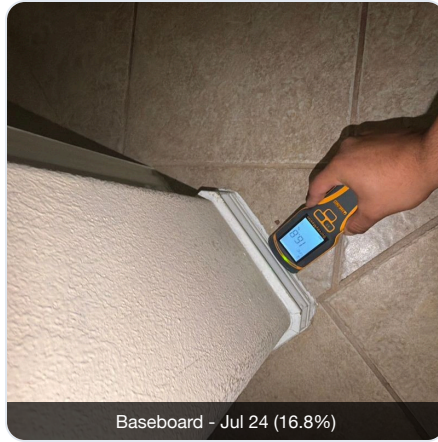
| | JUL 24 | JUL 25 | JUL 26 | JUL 27 |
|---|---|---|---|---|
| Baseboard<br>DRY STD 9% | 16.8% | 13.2% | 10.6% | 8.7% |

Baseboard - Jul 24 (16.8%)

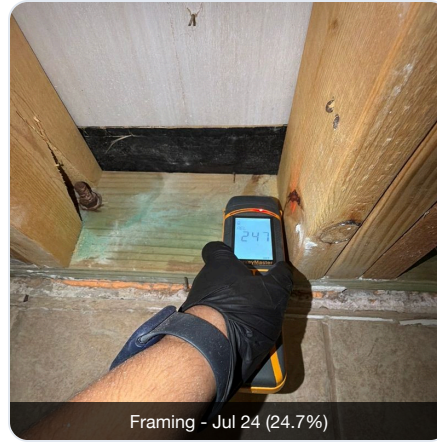
| | JUL 24 | JUL 25 | JUL 26 | JUL 27 |
|---|---|---|---|---|
| Framing<br>DRY STD 15% | 24.7% | 20.1% | 16.5% | 14.5% |

Framing - Jul 24 (24.7%)

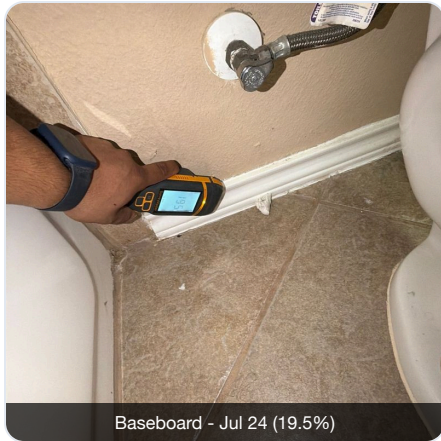
| | JUL 24 | JUL 25 | JUL 26 | JUL 27 |
|---|---|---|---|---|
| Baseboard<br>DRY STD 9% | 19.5% | 14% | 11.2% | 8.8% |

Baseboard - Jul 24 (19.5%)

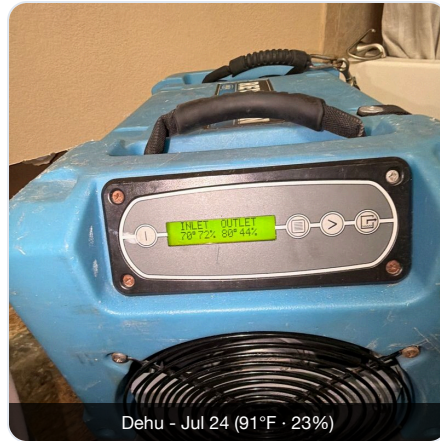
| | JUL 24 | JUL 25 | JUL 26 | JUL 27 |
|---|---|---|---|---|
| Dehu | 91°F · 23%<br>50 GPP · 42 GD | 94°F · 16%<br>38 GPP · 22 GD | 93°F · 13%<br>30 GPP · 16 GD | 91°F · 13%<br>28 GPP · 12 GD |

Dehu - Jul 24 (91°F · 23%)
