# Initial Report

1234 Andes Ln, San Marcos, Tx

Example Job - James Vasquez

Water

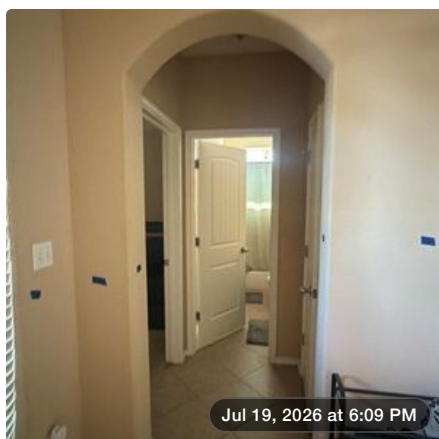
## Overview

There are baseboards, and drywall still containing high levels of moisture.

Following IICRC guidelines, materials that hold moisture for more than 72 hours, have a higher risk of microbial organism amplification.

Therefore, we recommend removal of any materials containing moisture.

Baseboard removal, 1 ft flood cuts, and insulation removal.

Anti-microbial was sprayed and all areas HEPA vacuumed.

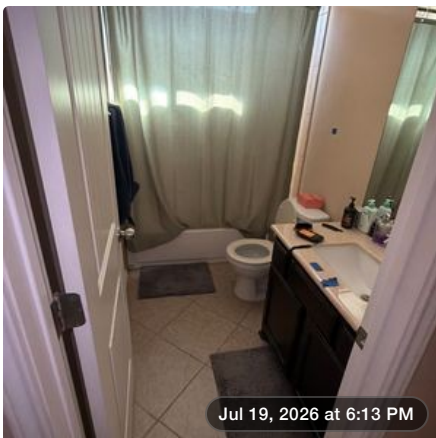
### Overview

Bathroom vanity still holds 99.9% moisture readings.

Following IICRC guidelines, materials that hold moisture for more than 72 hours, have a higher risk of microbial organism amplification.

Therefore, we recommend removal of any materials containing moisture.

All affected cabinetry that remained with 99.9% moisture, for more than 72 hours has been removed, per IICRC S500 guidelines.

After removing cabinetry, drywall behind was inspected, no discoloration, or moisture was present. therefore, no need to remove anything but the affected cabinetry.

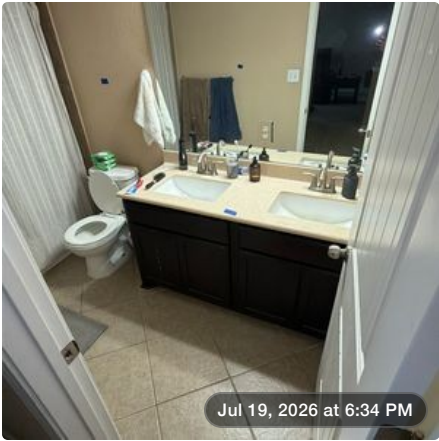
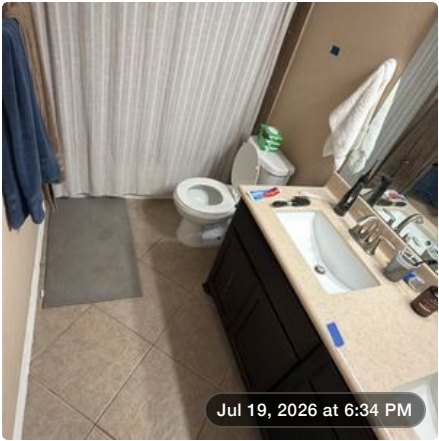
Overview

There are baseboards, drywall, tile flooring, subfloor beneath tile, and bathroom vanity still containing high levels of moisture.

Following IICRC guidelines, materials that hold moisture for more than 72 hours, have a higher risk of microbial organism amplification.

Remove the saturated ceramic flooring in the second-floor bathroom so the subfloor can be properly sanitized and dried. Pack out, asbestos, and mold concerns were not identified.

Therefore, we recommend removal of any materials containing moisture.
