# Drying Log

1234 Andes Ln, San Marcos, Tx

Example Job - James Vasquez

Water

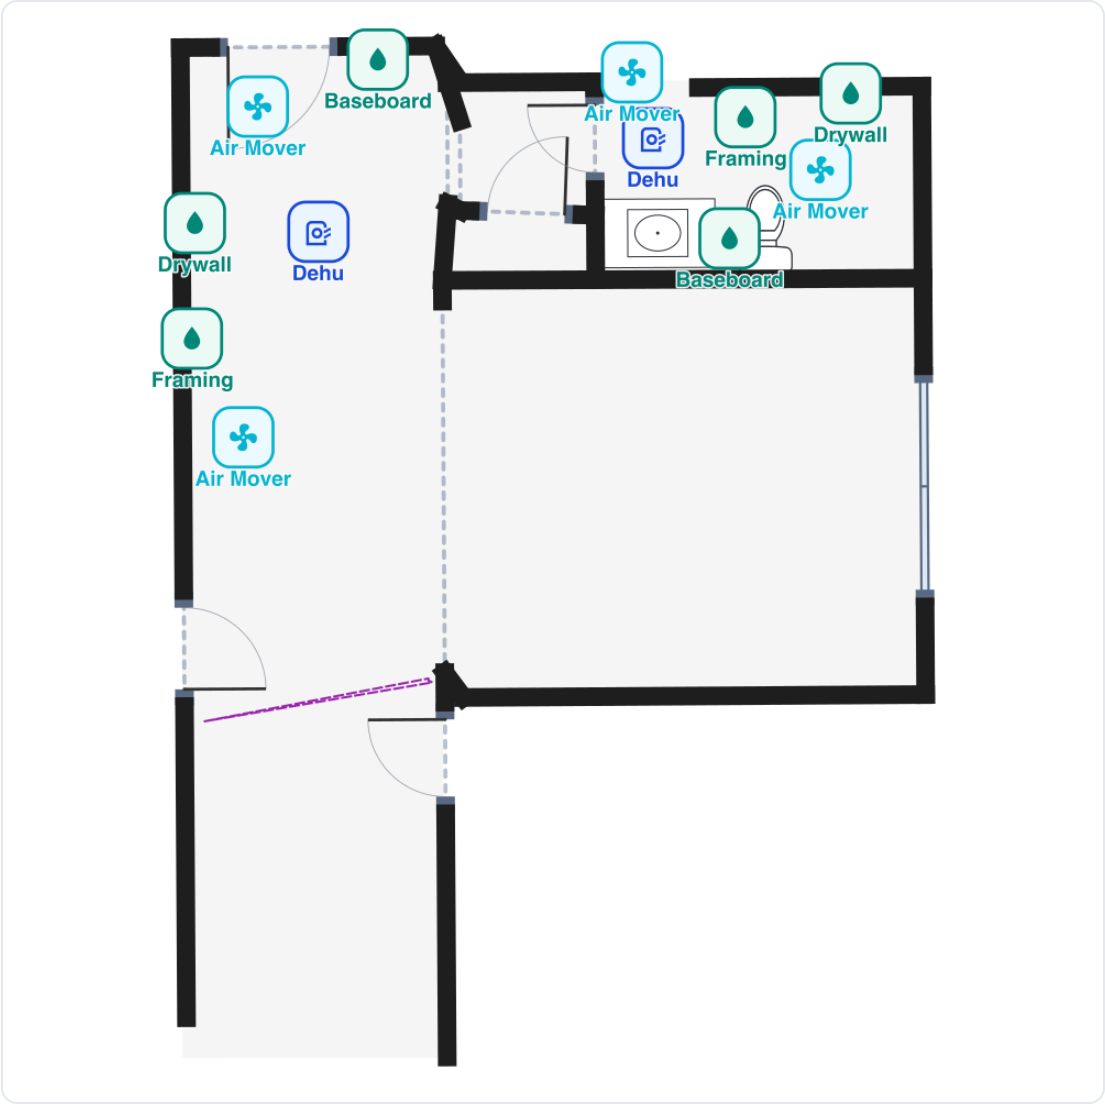
Main Level

Moisture Maps

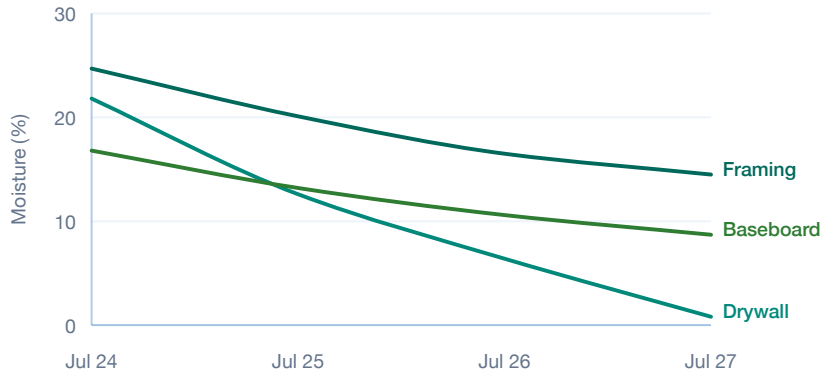
Moisture Points

| | JUL 24 | JUL 25 | JUL 26 | JUL 27 |
|---|---|---|---|---|
| Drywall<br>DRY STD 1% | 21.8% | 12.6% | 6.4% | 0.8% |
| Baseboard<br>DRY STD 9% | 16.8% | 13.2% | 10.6% | 8.7% |
| Framing<br>DRY STD 15% | 24.7% | 20.1% | 16.5% | 14.5% |

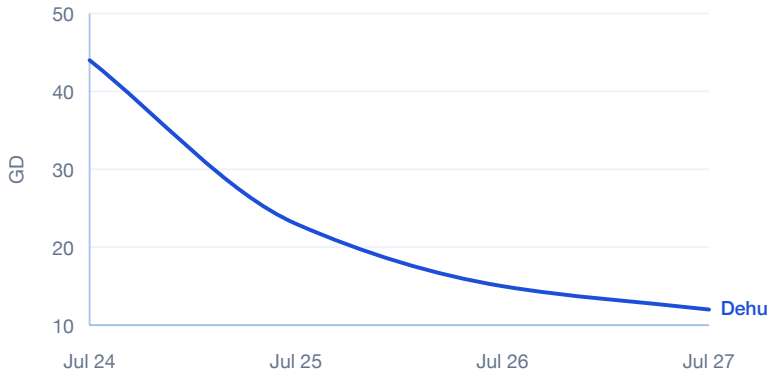
Dehumidifiers

| | JUL 24 | JUL 25 | JUL 26 | JUL 27 |
|---|---|---|---|---|
| Dehu | 92°F · 23%<br>51 GPP · 44 GD | 95°F · 16%<br>39 GPP · 23 GD | 94°F · 13%<br>31 GPP · 15 GD | 92°F · 13%<br>29 GPP · 12 GD |

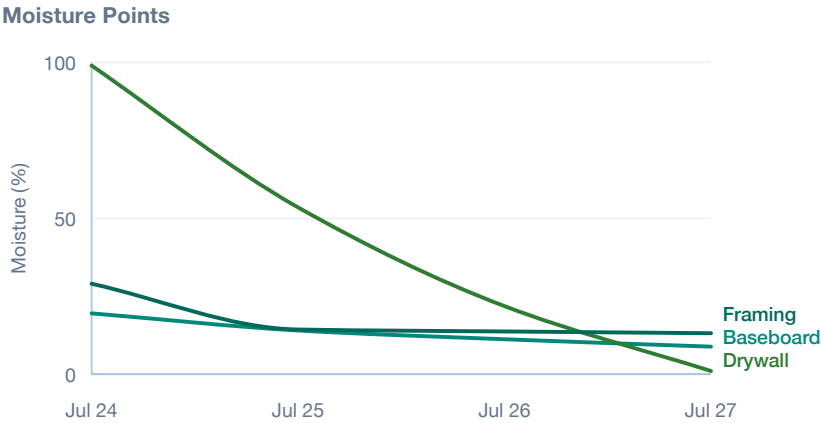
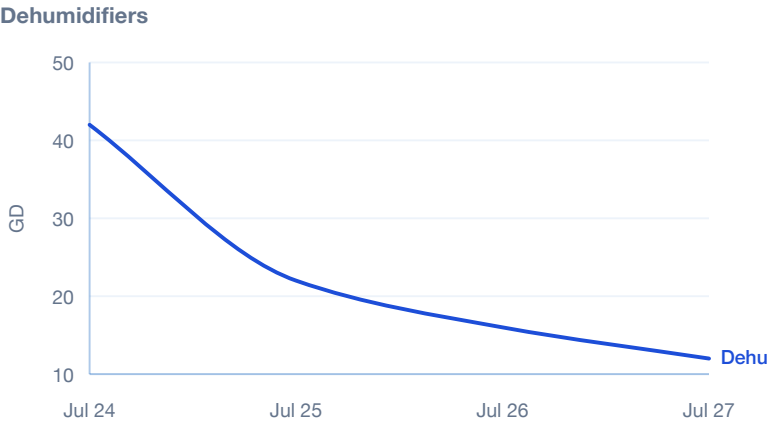
Upstairs Bathroom

| | JUL 24 | JUL 25 | JUL 26 | JUL 27 |
|---|---|---|---|---|
| Baseboard<br>DRY STD 9% | 19.5% | 14% | 11.2% | 8.8% |
| Drywall<br>DRY STD 1% | 99% | 53.5% | 21.8% | 1% |
| Framing<br>DRY STD 15% | 29% | 14.3% | 13.7% | 13.1% |
| Dehu | 91°F · 23%<br>50 GPP · 42 GD | 94°F · 16%<br>38 GPP · 22 GD | 93°F · 13%<br>30 GPP · 16 GD | 91°F · 13%<br>28 GPP · 12 GD |
